Manhole Inspection Summary

Manhole # S13UU1049MH

Record Plat: **13UU1** Node: **049** Status: **New Manhole (Not in GIS)** Insp Date: **4/10/07 12:00 AM**

Location Address: **NORTHERN PKWY** Cross Street: **BELVEDERE AVE**

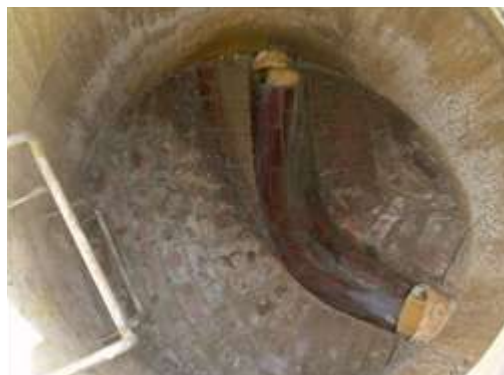
Top View

Bench ☒ Exists Material: **Brick** ☐ Parged ☒ **Debris** (not Condition related)
Condition: ☒ Sound ☐ Cracked ☐ Root Intrusion ☐ Deteriorated ☐ Leaks ☐ Debris

Bench debris.

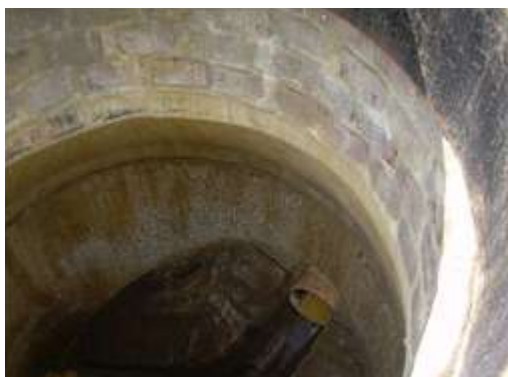
Defect

Chimney / Frame Adjustment ☒ Exists Material: **Brick** ☐ Parged Height: **12** (in.)
Condition: ☒ Sound ☐ Cracked ☐ Root Intrusion ☐ Loose Brick ☐ Deteriorated
Infiltration: ☐ None ☒ **Joint** ☐ Cracks ☐ Mortar ☐ Roots ☒ **Wall**

Corbel Material: **Precast Concrete** ☐ Parged Type: **Concentric/Eccentric**
Condition: ☒ Sound ☐ Cracked ☐ Root Intrusion ☐ Loose Brick ☐ Deteriorated
Infiltration: ☐ None ☒ **Joint** ☐ Cracks ☐ Mortar ☐ Roots ☒ **Wall**

Barrel Material: **Precast Concrete** ☐ Parged
Shape: **Circular** Diameter: **48** (in.) Length: (in.)
Condition: ☒ Sound ☐ Cracked ☐ Root Intrusion ☐ Loose Brick ☐ Deteriorated
Infiltration: ☐ None ☒ **Joint** ☐ Cracks ☐ Mortar ☐ Roots ☒ **Wall**

Adjustment, Corbel and Barrel infiltration.

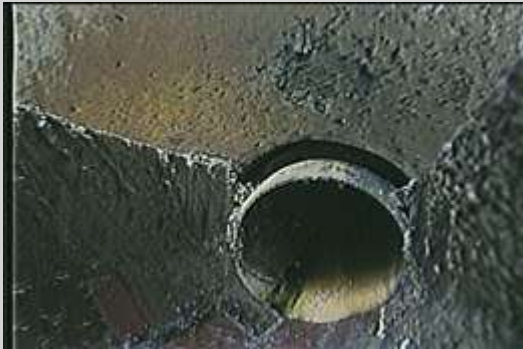
8 in. Circular Gravity Sewer Pipe Out @ 12 O'Clock

Infiltration: **None** Pipe Seal Cond: **Sound**

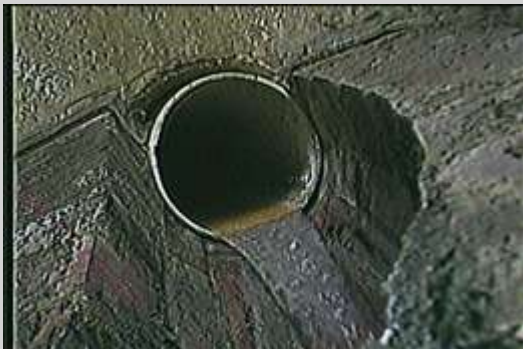
8 in. Circular Gravity Sewer Pipe In @ 4 O'Clock

Infiltration: **None** Pipe Seal Cond: **Sound**
